**CONTACT POINT**

# Exposure analysis using X-ray fluorescence device and a cobalt spot test in four patients with cobalt allergy

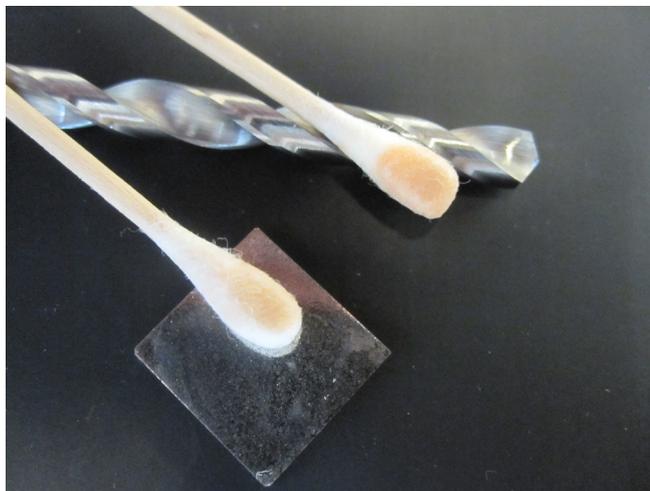
**FIGURE 1** Positive cobalt spot test to a drill

We found over 10 wt% cobalt in a cobalt drill along with a positive result in the cobalt spot test of the drill (Figure 1). Hard metal alloys constitute the primary cause of occupational allergic contact dermatitis to cobalt.<sup>5</sup> Consumer exposure to cobalt has been described as well, including jewelry and more recently leather objects. Based on a clinical case in 2013, suspicion was raised toward cobalt release from leather as a hitherto unrecognized source of cobalt allergy and dermatitis.<sup>6</sup> In this study,
